ENVIRONMENTAL ASSESSMENT REPORT  
OPERATION AND MAINTENANCE  
SAXON HARBOR, WISCONSIN  
LAKE SUPERIOR

DEPARTMENT OF THE ARMY  
1135 U.S. POST OFFICE AND CUSTOM HOUSE  
ST. PAUL, MINNESOTA 55101  
29 May 1975

TECHNICAL APPENDIX  
ENVIRONMENTAL ASSESSMENT REPORT  
SAXON HARBOR, WISCONSIN  
LAKE SUPERIOR

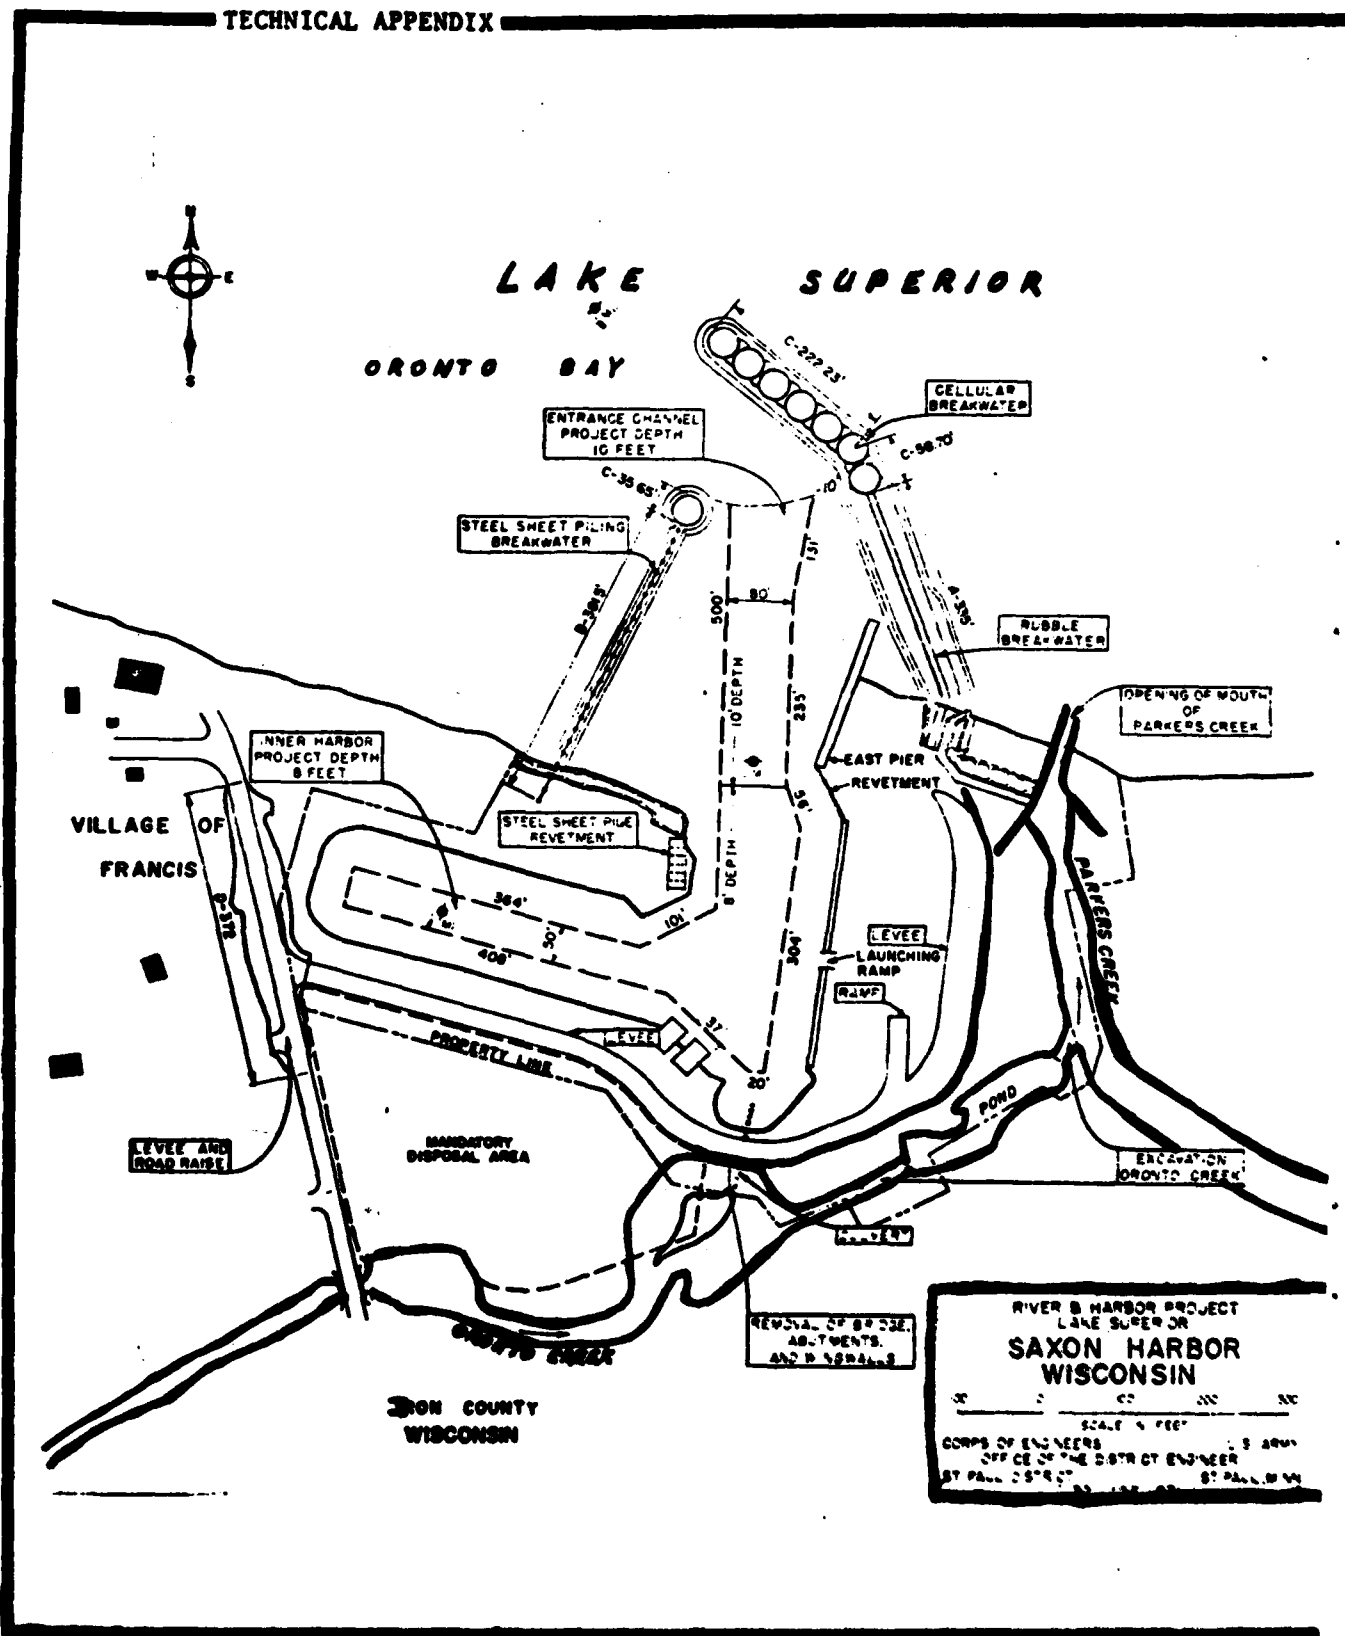
EXHIBIT 2

1.09 In addition, the Corps constructed two breakwaters, an outer channel, and an inner harbor basin. The west breakwater consists of 381 feet of steel sheet piling that projects 8 feet above the normal lake level. The west breakwater ends in one 35-foot wide steel cell. The cell, constructed of steel sheet piling, is filled with sand dredged from the harbor and capped with 2 feet of rock and concrete. The east breakwater consists of a 335-foot long stone mound on the land end connected to a 280-foot cellular breakwater on the lake end. The stone portion has a small rock core covered with larger stones and capped with a layer 6 feet thick of 3- to 5-ton boulders. The stone portion is of an inverted "V" configuration 8 feet wide at the top. The entire section projects 8 feet above the normal lake level. The end 280 feet of the east breakwater consists of seven steel cells of similar construction to the cell on the west breakwater. Stone protection repairs were made in 1972 when 1,033 tons of rock were placed at the east breakwater. Both breakwaters are equipped with U.S. Coast Guard navigational aid lights at the outer ends. The 10-foot deep outer channel narrows from 100 feet at its outer extremity 80 feet at the entrance to the inner basin. The irregularly-shaped inner basin is approximately 95 feet wide, 350 feet long and 8 feet deep with a side channel 50 feet wide, 450 feet long, and 8 feet deep (see Exhibit 2).
